WATER LOGGING RISKS IN DHAKA CITY: AN OVERVIEW AND THE WAY FORWARD

Zenat Islam¹, Shafinaz Sameen², Anika Tasnim Ananna³

Abstract

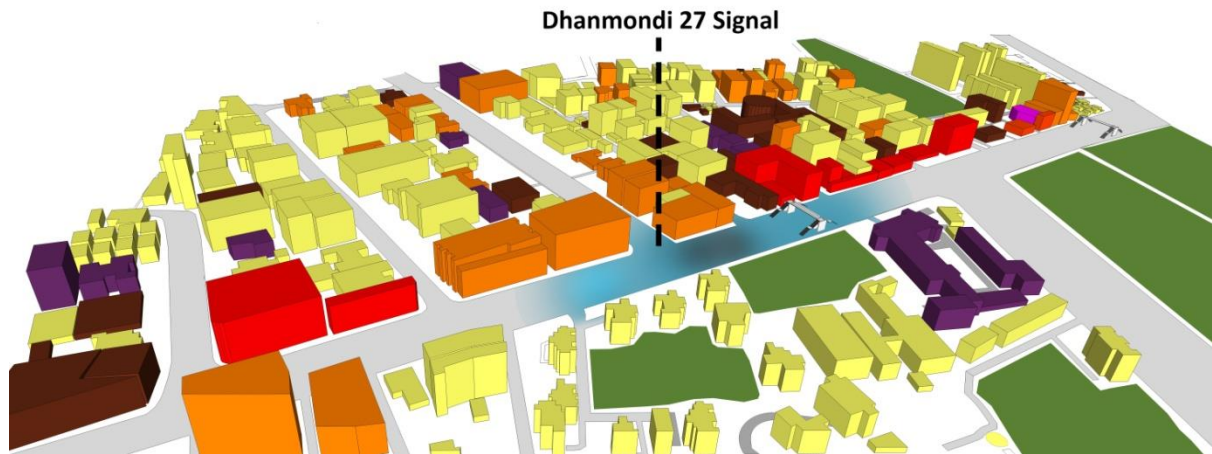
Figure 4: Image showing water stagnation in Mirpur road adjacent to Dhanmondi 27 signal, (During rainfall)

Moreover, in addition to shopping centers, that exist in a great number in the area, there are other commercial and institutional uses like private offices, cultural centers, restaurants, banks, etc all of which is making Dhanmondi a place of great rush and movement. These attract unwanted traffic, crowding, outside visitors, and cause scarcity of utility and resources, resulting in environmental deterioration (Chowdhury et al 2008). On the other hand Dhanmondi 27 signal and Mirpur road is a major arterial road of Dhaka that goes under water even in moderate rainfall. So the water logging of this point affects a large extent of population. Especially, in particular times of a day (i.e peak time of office travelers, end of school time etc.) the area mentioned faces haphazard situation. Figure 4 shows the worst affected area from in front of Rapa plaza to Sunrise plaza.

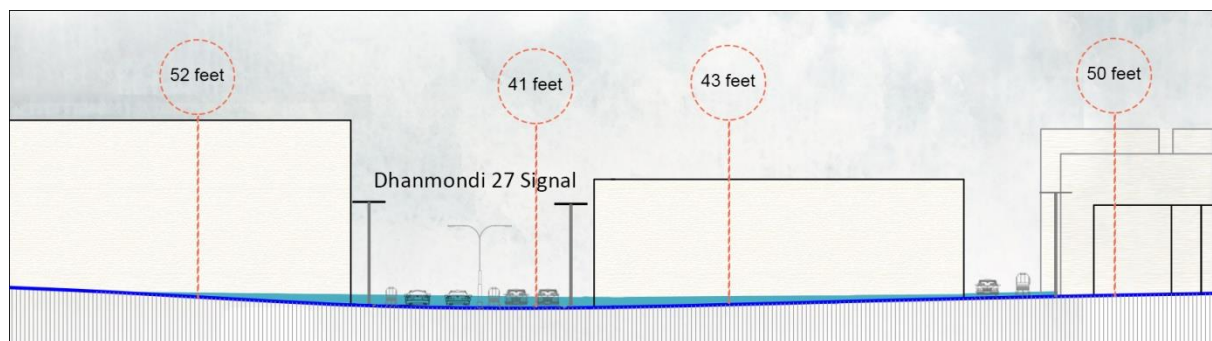
Figure 5: Section through Mirpur Road showing elevation data

The topographic data (Figure 5) showing different height of different points from the sea level where obvious the lower point is the Dhanmondi 27 signal.

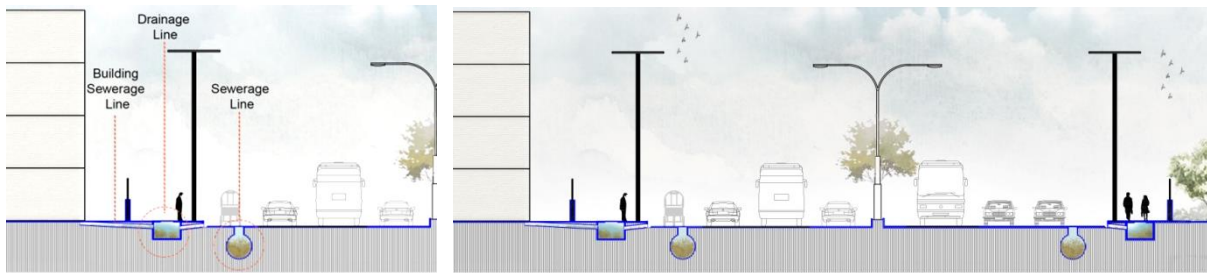
Figure 6: Section showing Sewerage line meet with drainage (left), Drainage full of garbage (right)

The poor drainage is another important cause of water stagnation in that point. Maximum area of the drainage line is filled up with garbage (Figure 6). Intrusion of commercial use in the residual area is in one hand welcoming more outsiders who are engaged in different activities and on the other hand resulting in increased use of local resources and waste formation (plastic bottles, bags, food container etc.) that are eventually clogging the roads and drains. In many cases the sewerage line is directly connected with the drainage line (Figure 6).

- Building construction rules if followed properly will ensure a great percentage of green space to allow water discharge.
- The prevailing laws regarding water body preservation if enacted may save the rest that are still in existence while retrieving the gone is not possible.
- Although mixed-use of buildings and lands are encouraged these days the extent may be defined and checked in order to secure a more local use of the commercial spaces than of a city scale.
- Maintenance of utilities (drainage, sewerage) on regular basis can solve the problem to a great extent by removing clogging of drainage and through monitoring of errors and need of repairing.
- Synchronization among different agencies (WASA, RAJUK, City Corporation etc.) can contribute to ensure sustainability of any endeavor regarding maintenance and repairing of sewerage, drainage or roads.

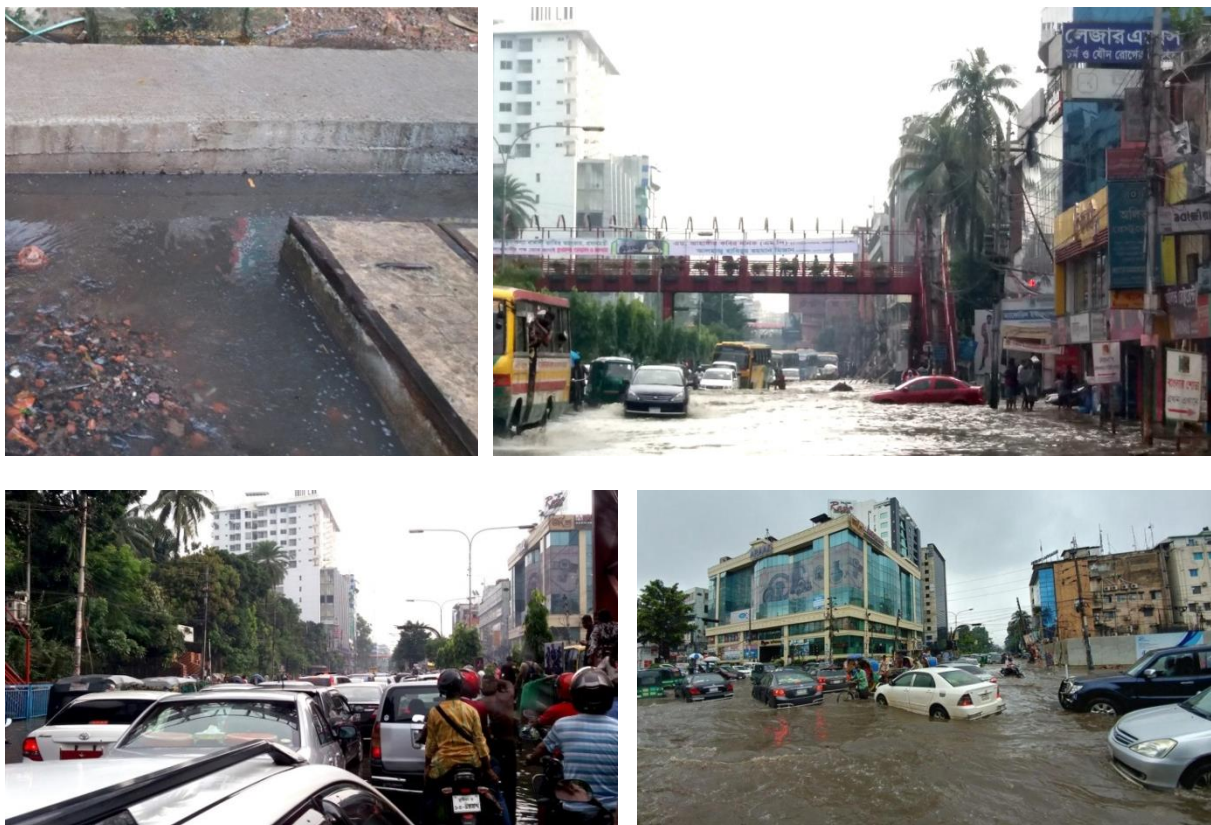
Figure 7: Water logging scenario in the site (taken 6 October 2017).

Despite of the presence of green areas and Dhanmondi Lake the particular area goes under water during monsoon as water cannot flow towards those areas. Apparently the lower elevation and uneven construction and clogged drains make water to stagnate and disrupt not only the local area residents but also the daily activities of people from a varying background who use the road. In this context, the area being an important point of connecting the whole city, it is imperative that this issue is considered seriously.
