Experimental investigation of damage behavior of RC frame members including non-seismically designed columns

Abstract: Reinforced concrete (RC) frame structures are one of the mostly common used structural systems, and their seismic performance is largely determined by the performance of columns and beams. This paper describes horizontal cyclic loading tests of ten column and three beam specimens, some of which were designed according to the current seismic design code and others were designed according to the early non-seismic Chinese design code, aiming at reporting the behavior of the damaged or collapsed RC frame structures observed during the Wenchuan earthquake. The effects of axial load ratio, shear span ratio, and transverse and longitudinal reinforcement ratio on hysteresis behavior, ductility and damage progress were incorporated in the experimental study. Test results indicate that the non-seismically designed columns show premature shear failure, and yield larger maximum residual crack widths and more concrete spalling than the seismically designed columns. In addition, longitudinal steel reinforcement rebars were severely buckled. The axial load ratio and shear span r

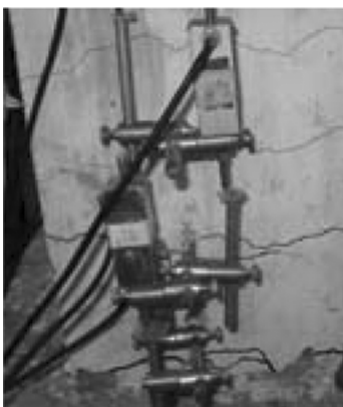
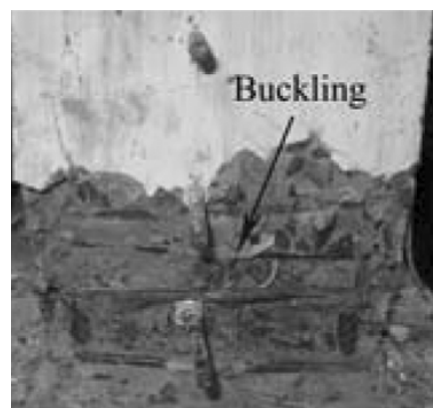
Fig. 3 Typical flexural failure of column specimens

The sequence of damage according to the first occurrence was observed as follows: concrete cracking, yielding of the longitudinal rebar, initial spalling of the concrete cover, final spalling of the concrete cover, buckling of the longitudinal rebar and fracture of the longitudinal rebar. No fracture of hoops was found during any of the tests of the specimens. It was observed that flexural behavior dominated during tests of all specimens except column specimen C505C, which was designed according to the non-seismic code with hoop spacing of 250 mm. The crack width at first emergence was below 0.02 mm and spacing between cracks was approximately equal to the hoop spacing. Although the cracks became wider as the horizontal displacements increased, the maximum crack width during the second and third cycle was roughly the same as during the first cycle, and new cracks rarely emerged during repeated cycles of the same displacement amplitude. After yielding of the longitudinal rebar buckled, the concrete cover at the bottom of the specimens began spalling. The cover spalling continued until the longitudinal rebar buckled and crushed the concrete core. Typical flexural failure is shown in Fig. 3.

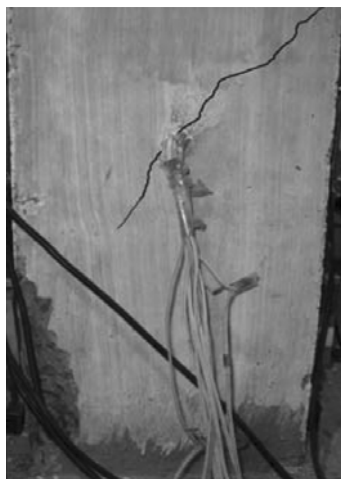
(a) formation of diagonal crack

(b) developing of diagonal crack

Fig. 4 Remarkable shear damage of column (C505C)

observed during the great Wenchuan Earthquake in RC frame structures designed according to early Chinese non-seismic codes. In these tests, the transverse reinforcement of specimen C505C was below the minimum requirement stipulated by the Chinese seismic design code (Ministry of Construction of China, 2002). The main diagonal crack appeared during the cycle with a displacement amplitude of 24 mm, and developed sharply. As illustrated in Fig. 4, as the main diagonal crack reached a width 15.5 mm, all longitudinal rebars buckled below the first stirrup away from the specimen bottom. The corner longitudinal rebars even buckled between the first and second stirrup from the bottom, indicating the weak confinement of the transverse reinforcement.

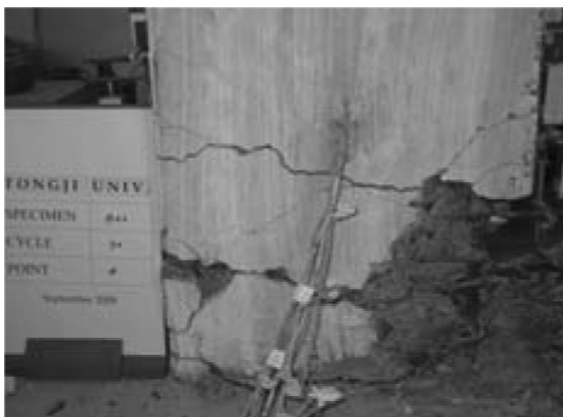
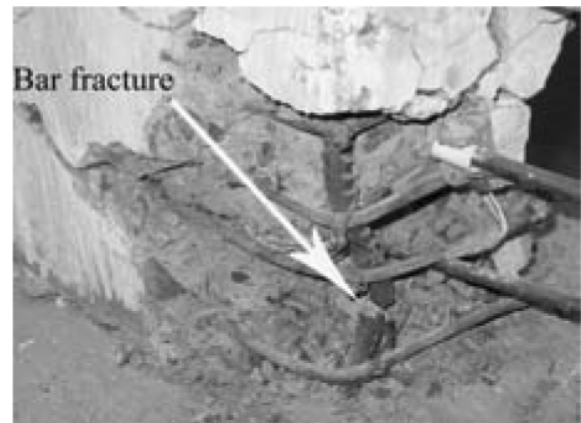
Fig. 5 Asymmetric damage behavior in beam specimens

Compared to the symmetric damage on the opposite sides of the column specimens, damage to beam specimens was observed to be asymmetric, as shown in Fig. 5. Due to the fact that longitudinal reinforcement in the upper region of the beam specimen was about twice as much as in the bottom region, cover spalling first occurred on the weakly reinforced bottom region, as did the concrete core crushing. The concrete cover in the upper region, however, remained almost intact until the tests were finished. This is because when the upper region was in compression, the height of the compression region was fairly small, which was verified by the equilibrium of the vertical force acting on the beam section with great disparity of longitudinal reinforcement on two sides and no vertical load exerted. Therefore, the compressive concrete strains at the section edge did not reach an ultimate flexure value.

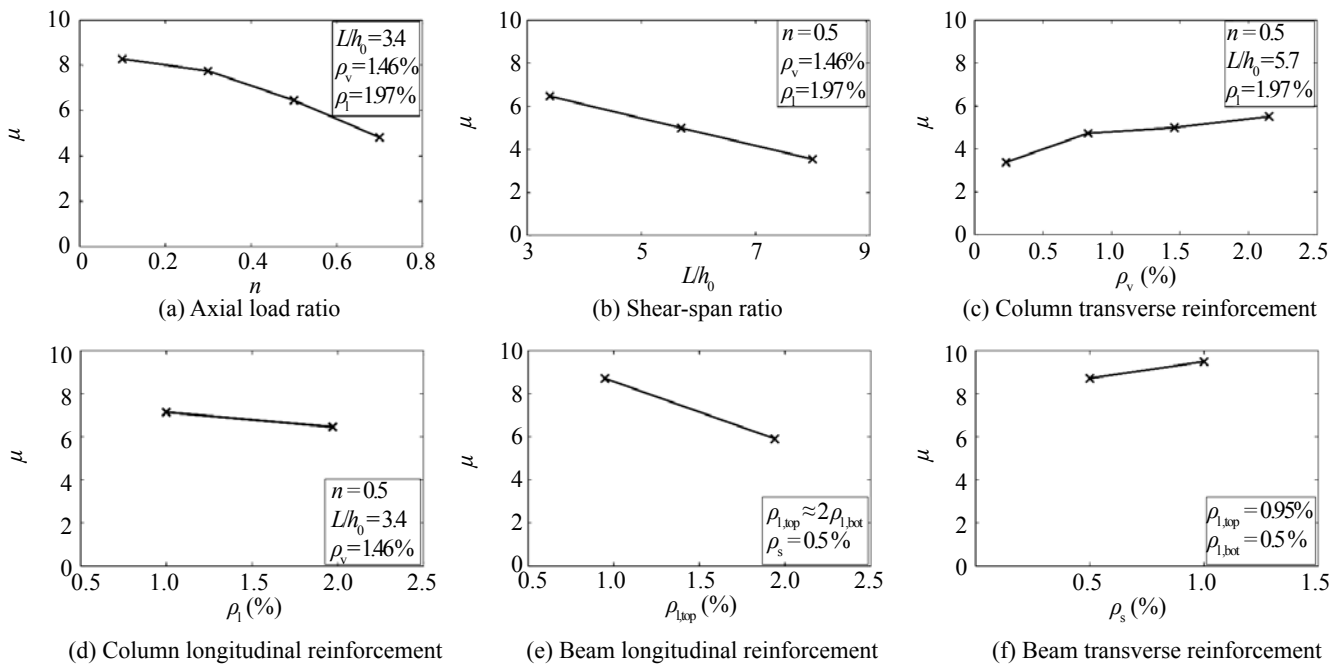
**Fig. 8 Effect of different design parameters on specimen ductility coefficient**

to their axial load ratios, shear-span ratios and so on, so that all specimens in each group differ from each other by only one variable parameter. As shown in Fig.8, there were six groups available for the comparative investigation, among which four were for columns and two were for beams. In the axial load ratio group, the ductility coefficient decreased from 8.27 to 4.81 by 42 percent when the axial load ratio increased from 0.1 to 0.7, indicating that the axial load ratio has a significant effect on ductility. A similar situation was observed in the shear-span ratio group, which consists of specimens C305, C505 and C705 with L/h_0 of 3.4, 5.7 and 8.0, respectively. As the shear-span ratio increased from 3.4 to 8.0, the column ductility coefficient decreased from 6.46 to 3.53 with a 45 percent drop. Note that in the column volumetric transverse reinforcement ratio

group, the non-seismically designed column yield had a lower ductility coefficient than the seismically-designed columns. For the seismically designed columns, the ductility coefficient increased from 4.72 to 5.50 by 16.5 percent as the transverse reinforcement ratio increased from 0.83% to 2.15%. A similar trend was observed for the area transverse reinforcement ratio group of beams. The longitudinal reinforcement ratio seemed to have a slight influence on the column ductility. The ductility coefficient decreased by 9.5 percent as the longitudinal reinforcement ratio increased from 1.00% to 1.97%. Since the longitudinal reinforcement in the upper region of the beam specimens was approximately

twice that of the bottom region, the reinforcement ratio in the upper region was chosen as the abscissa. When the longitudinal reinforcement ratio in the upper region nearly doubled, the ductility coefficient decreased by 32 percent, demonstrating the pronounced effect of the longitudinal reinforcement ratio on beam ductility when compared to the columns.

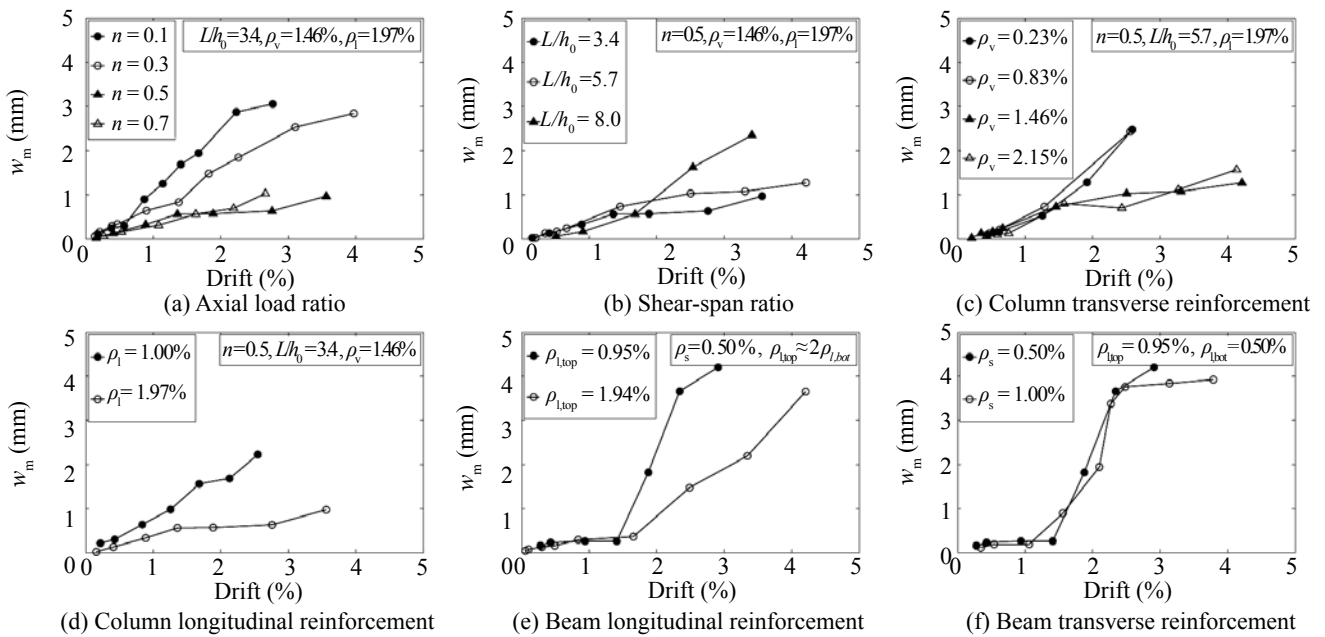
Fig. 9 Maximum crack width at peak drift

increase. As illustrated in Fig. 9 and Fig. 10, the axial load ratio appears to be the most important factor for crack development. Both the maximum crack width and the maximum residual width decrease sharply as the axial load ratio increases, demonstrating the remarkable restraining effect of axial load on crack opening and its effect on promoting crack closing. Conceptually, the shear-span ratio presents a quantitative relationship between section moment and shear force. When the drift was less than 2%, w_m and $w_{m,res}$ of specimens with shear-span ratios of 3.4, 5.7 and 8.0 were generally

approximate to each other. For drift greater than 2%, cracks in specimens with larger shear-span ratios reached larger width during the loading process and remained larger when unloaded, implying the gradually increasing bending effect on columns. As for the group with a variable transverse reinforcement ratio, w_m of specimen C505S was much larger than specimens C505 and C505D, but near to C505C. This is explained as follows. Specimens C505C, C505S and C505 have the same hoop diameter of 6.5 mm (see Table 3). Their transverse reinforcement ratios were changed by the variation of hoop spacing. However, the hoop diameter of specimen C505D was 8 mm with the same spacing as specimen C505. Because of the weakening of the section brought by the hoops and the variation of bonding stress between the rebar and concrete, spacing of cracks often coincided with hoop spacing. It was generally accepted that larger spacing of cracks resulted in larger crack width; that is, sparse but wide cracks. This explains why the w_m of specimens C505 and C505D were approximate to each other and much less than for specimen C505S. Although hoop spacing in C505C was 3.6 times specimen C505S, new cracks formed between the existing ones as a result of the accumulation of bonding stress amounting to concrete tensile strength, which was why these two specimens yielded almost the same w_m . The $w_{m,res}$ of the seismically designed columns were very close to each other, but much less than in the non-seismically designed columns. When the drift was less than 2.5%, the area ratio of the beam transverse reinforcement was not significant on w_m and $w_{m,res}$. While the drift continued to increase, smaller values of w_m and $w_{m,res}$ were obtained for beams with denser hoops. The w_m and $w_{m,res}$ decreased as the longitudinal reinforcement ratio

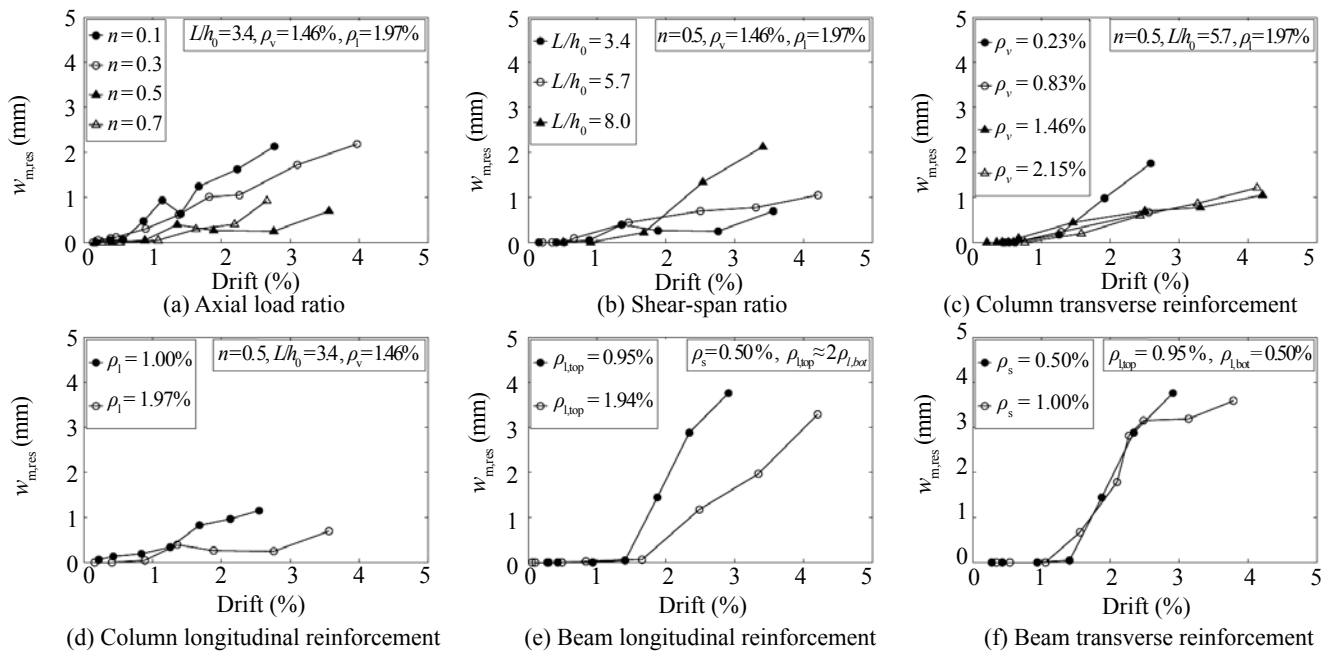
Fig. 10 Maximum residual crack width at zero lateral force

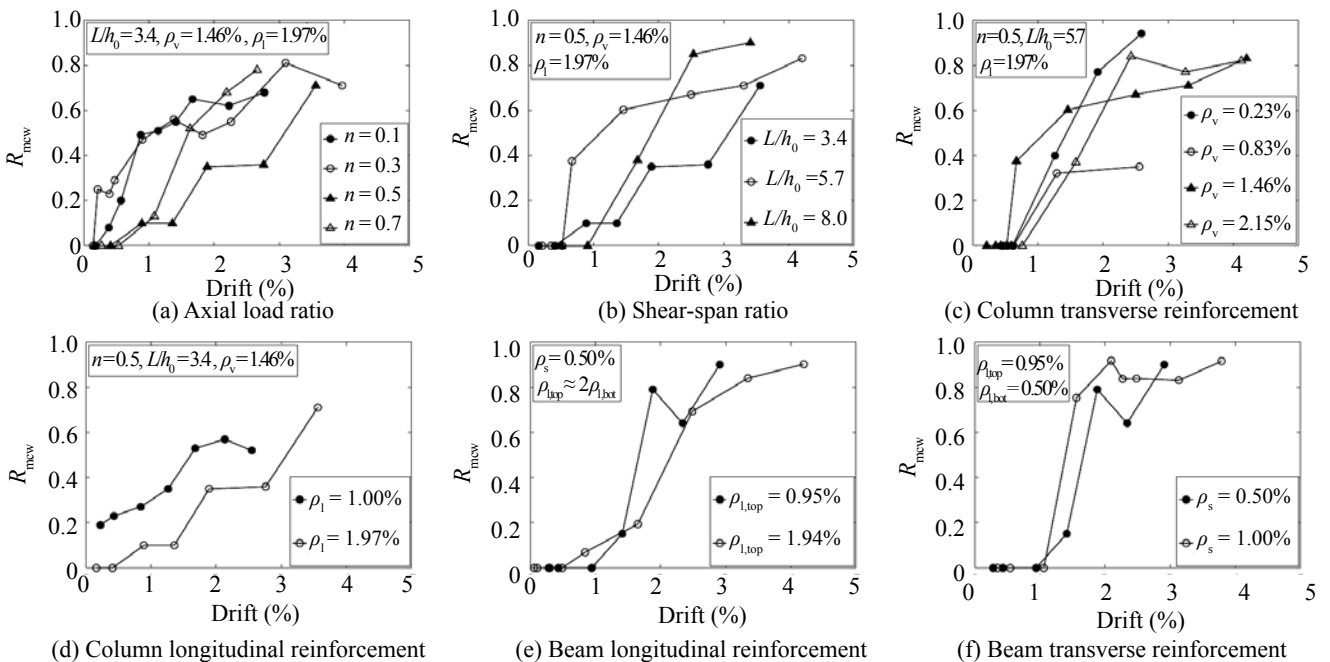
Fig. 11 Residual coefficient of maximum crack width vs drift for different design parameters

As shown in Fig. 11 and the corresponding damage characteristics shown in Table 4, most R_{mcw} curves ascended sharply after the longitudinal reinforcement yielded, and remained at high levels, suggesting the deterioration of crack closing capability caused by rapid accumulation of damage. The increase of the axial load ratio on the whole had a positive effect on crack closing. R_{mcw} gradually decreased as the axial load ratio increased from 0.1 to 0.5. The exception was that the R_{mcw} for an axial load ratio equal to 0.7 exceeded those for other axial load ratio values when drift was greater than 1%, which may result from the severe deterioration of restorability for lateral deformation due to the excessive axial load. The increase of the shear-span ratio had a negative effect on crack closing ability. No consistent relationship was found between R_{mcw} and the column transverse reinforcement ratio. Hence, the transverse reinforcement ratio did not seem to influence the crack closing ability of columns, although it affected w_m and $w_{m,res}$. This was also confirmed by the variation of R_{mcw} for beam specimens. The R_{mcw} of columns and beams were reduced by increasing the longitudinal reinforcement, indicating its positive influence on crack closing ability.
